Shoreline Flooding and Erosion Hazards in the Long Point Area

Working Paper 7

Patrick L. Lawrence and J. Gordon Nelson

August, 1994

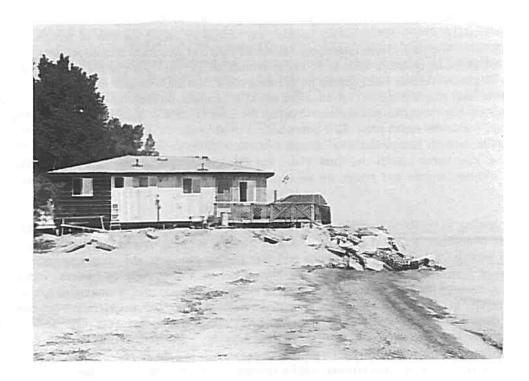
Photo # 1. Cottage on Hastings Drive

The natural processes of flooding and erosion are in turn greatly influenced by a variety of human activities. The use of shore protection structures, such as concrete walls (Photo # 1) and stone groynes can trap sediment transported alongshore by wave action resulting in loss of sediment further along the shoreline. Development of cottages (Photo # 2), marinas (Photo # 3), channels, and boat slips can also change the natural patterns of sediment movement. Buildings in low-lying shoreline areas are prone to flooding during periods of higher water levels. Continued dredging for sand and construction purposes alters shoreline and offshore surfaces can create increased potential for flooding. Only when human activities are allowed in areas prone to flooding and erosion (Photo # 4), is a hazard created. The magnitude of these hazards is often described in terms of damage to properties.
